## **2018 Operations, Maintenance, and Monitoring Report**

### **Bayou Chevee Shoreline Protection (PO-22)**

State Project Number PO-22  
Priority Project List 5

December 2018  
Orleans Parish

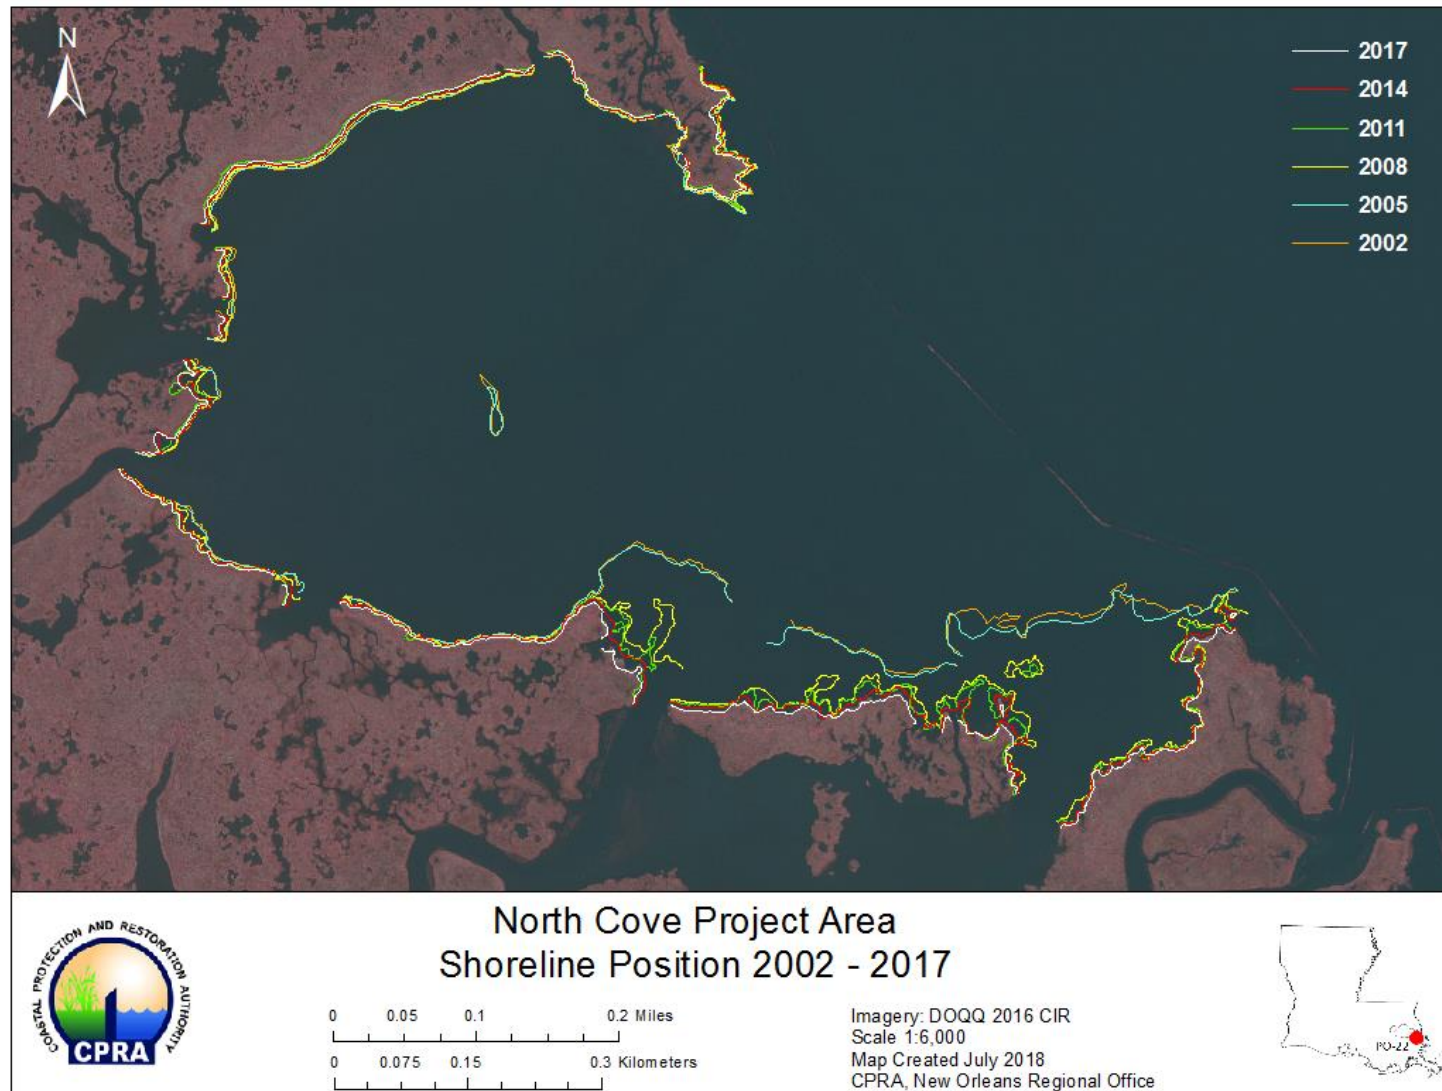
**Figure 3.** 2002, 2005, 2008, 2011, 2014 and 2017 shoreline position for the North Cove project area of the Bayou Chevee Shoreline Protection (PO-22) project.

All areas have experienced some shoreline retreat since the previous survey in 2014. For the period of time from 2014 to 2017 the North Cove project area experienced an average rate of shoreline retreat of 3.9 ft/yr (Table 1) and an average net shoreline loss of 11.1 ft (Table 2). Similar to the trend observed in previous surveys, the majority of the shoreline retreat in the North Cove project area occurred on the north facing bank along the southeastern shoreline (Figure 3).

Rates of shoreline retreat in the North Cove project area have been greater than the reference area's interior pond in all time periods since construction, and greater than the reference area's Lake Pontchartrain shoreline in 2 of the 5 periods since construction (Table 1). Much of the shoreline retreat in the North Cove project area is concentrated along the southeastern shoreline. One explanation for the greater rate in the project area is the large extent of the open water area behind the rock structure in the North Cove. The open water area is as much as 700 yds across measured north to south. It is likely that waves which are broken by the structure are able to re-form behind the structure and impact the shoreline. Another possibility is that the subsidence of the rock structure in the North Cove project area has reduced its effectiveness in reducing wave energy.

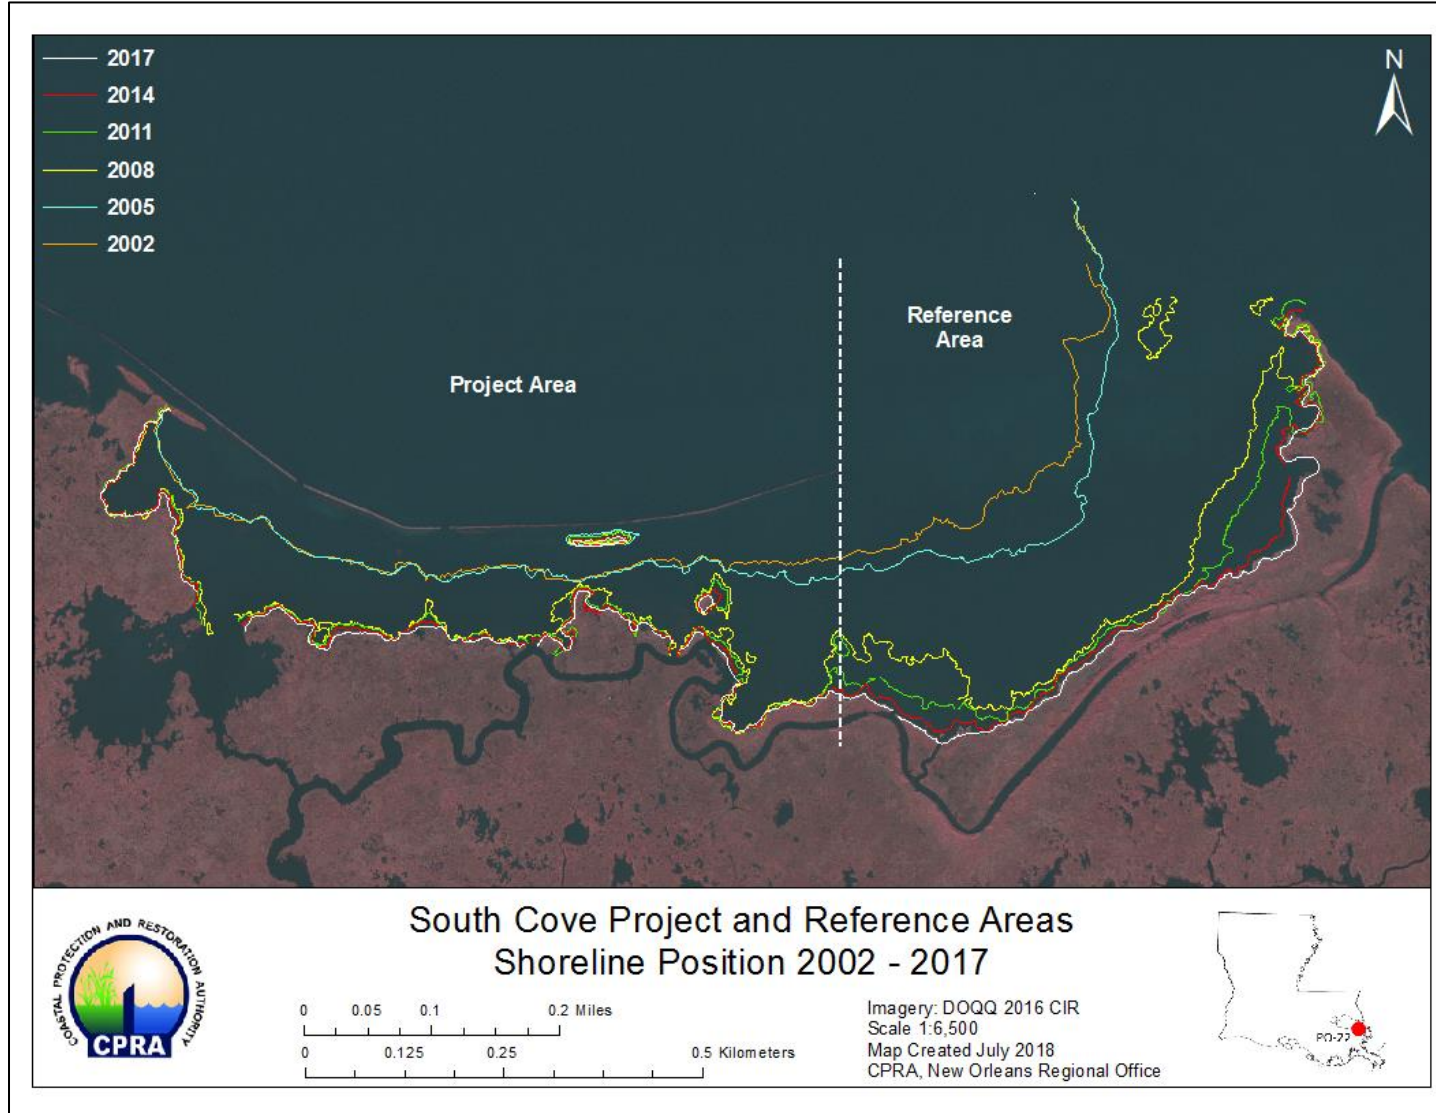
**Figure 5.** 2002, 2005, 2008, 2011, 2014, and 2017 shoreline positions for the South Cove project and reference areas of the Bayou Chevee Shoreline Protection (PO-22) project. The dashed line indicates the boundary between project and reference areas.

For the 2014 – 2017 time period, the South Cove project area experienced an average rate of shoreline retreat of 3.2 ft/yr (Table 1), and an average net shoreline loss of 9.1 ft (Table 2). The island created directly behind the rocks from the placement of spoil during construction remains intact, although it has decreased in size with each successive survey (Figure 5). Since construction, shoreline retreat along the eastern end of the South Cove project area has been greater than the western end. This phenomenon can be explained by the termination of the rock structure offshore rather than on land. Waves approaching from the northeast are not broken by the rocks and therefore are able to impact the shoreline behind the structure.

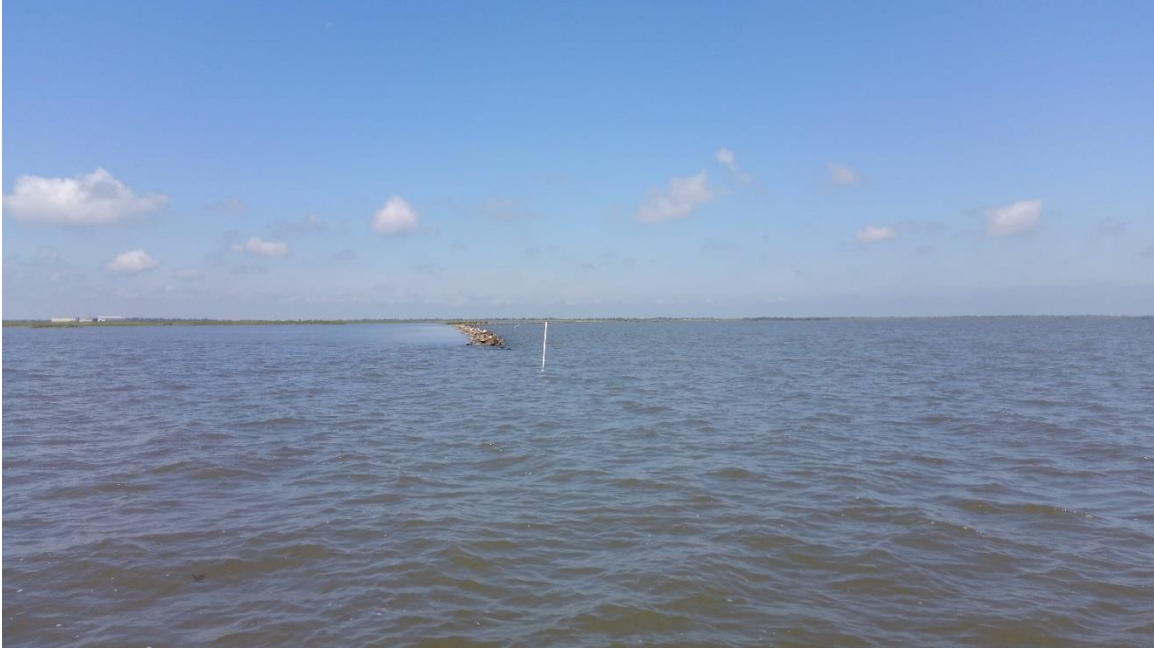
**Photo #1 – Terminus of Southern Reach.**

A majority of the rock dikes have settled below the acceptable grade of 1.0 ft NAVD88. The rock structure has maintained its shape although some sections were beneath the water surface. No mud waves or loose geotextile were noticed. The settlement plates at each fish dip have corroded away and are no longer visible or functional.

Item	Condition	Physical Damage	Corrosion	Photo #	Observations and Remarks
Foreshore Rock Dike North Cove	Fair	Settling	N/A	3	North end looking good. South end settling below acceptable grade.
Foreshore Rock Dike South Cove	Poor	Settling	N/A	1, 2	Settling below acceptable grade.
USFWS Dike Segment	Poor	Settling	N/A		Settled below acceptable grade.
Settlement Plates	Poor	Heavy Corrosion	Heavy		Some plates have corroded through and are no longer visible. The rest are leaning too far out of plumb to give accurate data.
					<b>Remarks: Project needs maintenance lift.</b>

The rock structure has settled significantly from the original constructed elevation. The inspection team discussed a maintenance rock lift, which would require a request for additional funds due to the insufficient amount of remaining Operations and Maintenance funds. The agreed upon course of action is for the project team to perform an existing condition survey, design a rock lift, request the necessary funding from CWPPRA, and perform the lift within the final three years of the project life (FY20-FY22). This would prove to be most beneficial for the future benefits of this project feature.
